**Flood Control Project Maintenance  
Levee Inspections**

**Fall 2013 Levee Maintenance Deficiency Summary Report**

**Sutter Maintenance Yard Maintenance Area 0007**

Waterway			Bank	Unit Miles
Unit No. 01 Feather River			Right	12.07
	Spring (March - May)	Summer (June - August)	(September - November) Fall	Winter (December - February)
Unit Maintenance Rating (Fall Only)			<b>A</b>	
Date of Inspection	04/08/2013 - 04/08/2013		10/21/2013 - 10/21/2013	
DWR Inspector	Rick Burnett		Matthew Hoffman	
Accompanied By	Jason Cooper Sutter Maintenance Yard		Jason Cooper Sutter Maintenance Yard

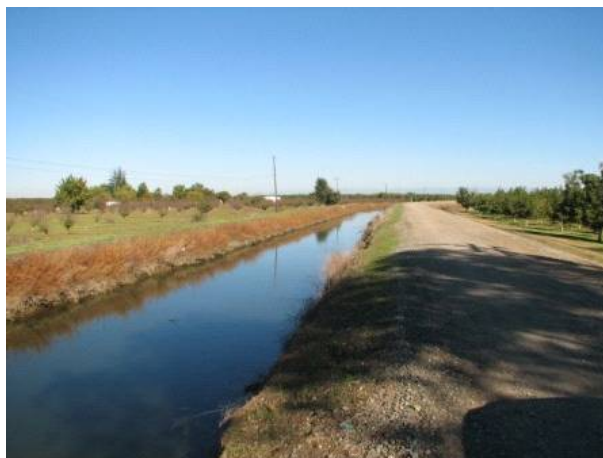
mhoffman\_f\_20130917\_026.jpg

Levee Mile Report Line	5
Start Levee Mile	0.42
End Levee Mile	0.42
Location	Land Side
Category	Earthen Levee
Item	Trim / Thin Trees

This photo was taken from the levee crown facing south looking down the landward slope at a tree growing near the toe. Fall 2013.

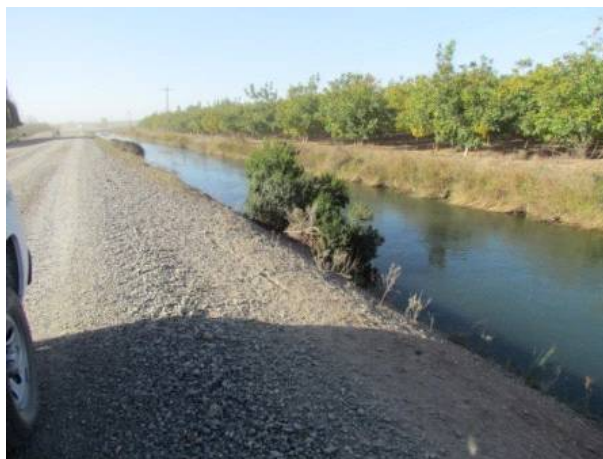
mhoffman\_f\_20131028\_674.JPG

Levee Mile Report Line	6
Start Levee Mile	0.46
End Levee Mile	0.46
Location	Water Side
Category	Earthen Levee
Item	Animal Control

This photo was taken from the crown of the levee facing north looking down the slope at rodent holes. Fall 2013.

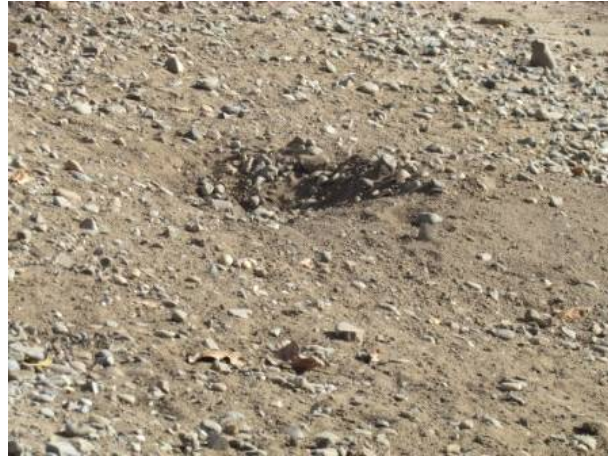
mhoffman\_f\_20131028\_676.JPG

Levee Mile Report Line	7
Start Levee Mile	0.51
End Levee Mile	0.51
Location	Land Side
Category	Earthen Levee
Item	Slope Stability

This photo was taken from the levee crown facing north looking down the landward levee slope at stability issues. Fall 2013.

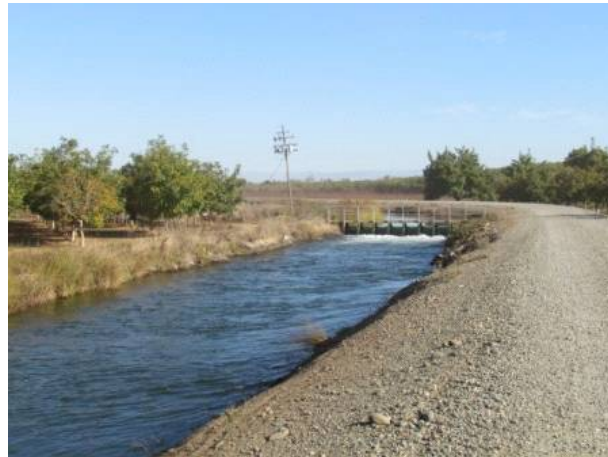
mhoffman\_f\_20131028\_677.JPG

Levee Mile Report Line	7
Start Levee Mile	0.51
End Levee Mile	0.51
Location	Land Side
Category	Earthen Levee
Item	Slope Stability

Close up of said slope stability issue. Fall 2013.

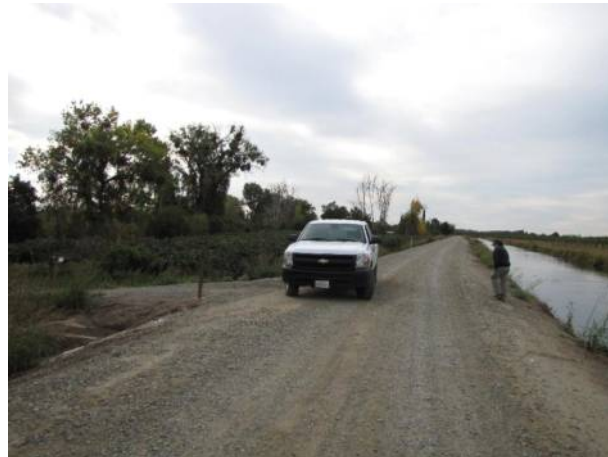
Levee Mile Report Line	11
Start Levee Mile	1.54
End Levee Mile	1.54
Location	Water Side
Category	Supplemental
Item	DWR UCIP Field Study
View of levee crown looking downstream.	
UCIP_6870.jpg

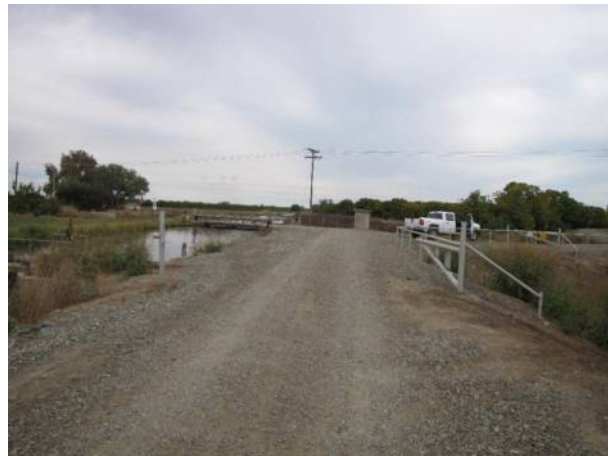
Levee Mile Report Line	21
Start Levee Mile	1.72
End Levee Mile	1.72
Location	Water Side
Category	Supplemental
Item	DWR UCIP Field Study
Overview of levee crown looking upstream at crossing.	
UCIP_5651.jpg

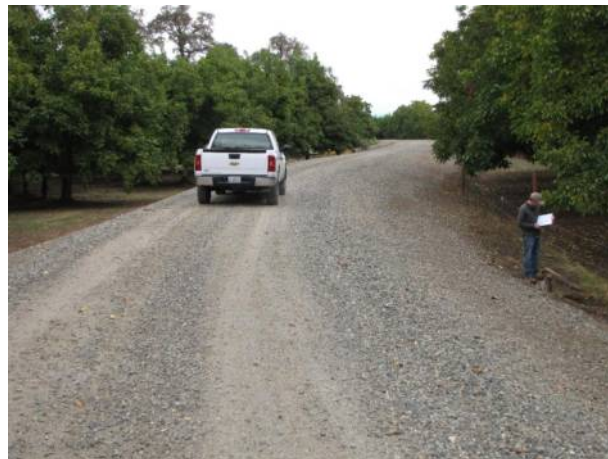
UCIP\_5556.jpg

Levee Mile Report Line	43
Start Levee Mile	1.94
End Levee Mile	1.94
Location	Land Side
Category	Supplemental
Item	DWR UCIP Field Study

Overview of levee crown looking upstream.

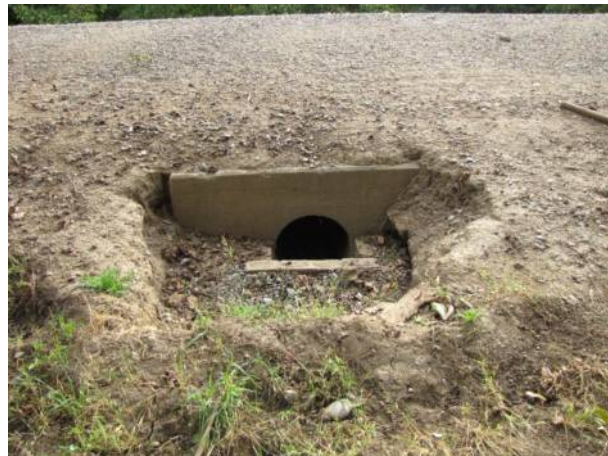
UCIP\_3192.jpg

Levee Mile Report Line	46
Start Levee Mile	2.10
End Levee Mile	2.10
Location	Land Side
Category	Supplemental
Item	DWR UCIP Field Study

View of headwall and inlet from landward side.

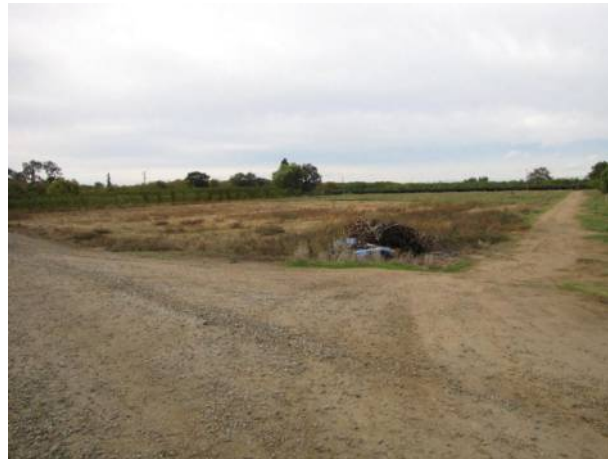
UCIP\_6998.jpg

Levee Mile Report Line	51
Start Levee Mile	2.25
End Levee Mile	2.25
Location	Land Side
Category	Supplemental
Item	DWR UCIP Field Study

Concrete distribution box located approximately 400-500 feet from landward toe.

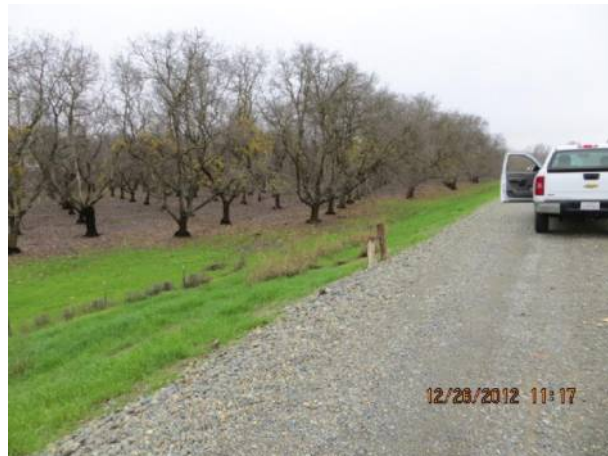
UCIP\_5640.jpg

Levee Mile Report Line	58
Start Levee Mile	2.37
End Levee Mile	2.37
Location	Land Side
Category	Supplemental
Item	DWR UCIP Field Study

View of waterward side at crossing.

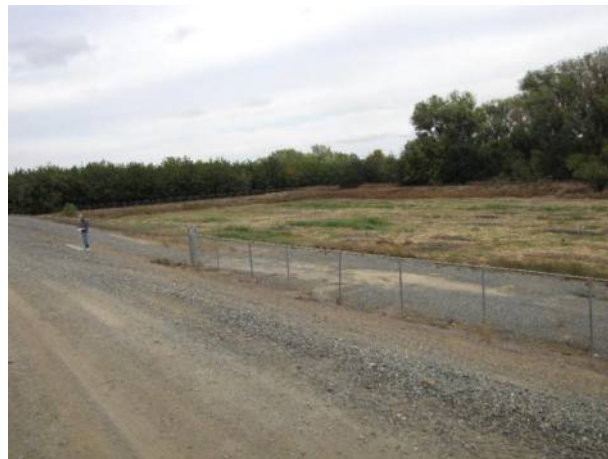
UCIP\_3220.jpg

Levee Mile Report Line	71
Start Levee Mile	2.74
End Levee Mile	2.74
Location	Water Side
Category	Supplemental
Item	DWR UCIP Field Study

View of waterward slope looking upstream. Matt is standing near CMP riser.

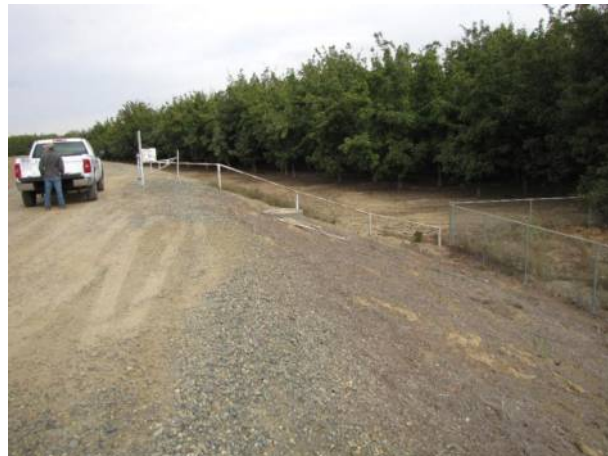
UCIP\_6739.jpg

Levee Mile Report Line	78
Start Levee Mile	2.83
End Levee Mile	2.83
Location	Water Side
Category	Supplemental
Item	DWR UCIP Field Study

View of waterward slope looking at crossing.

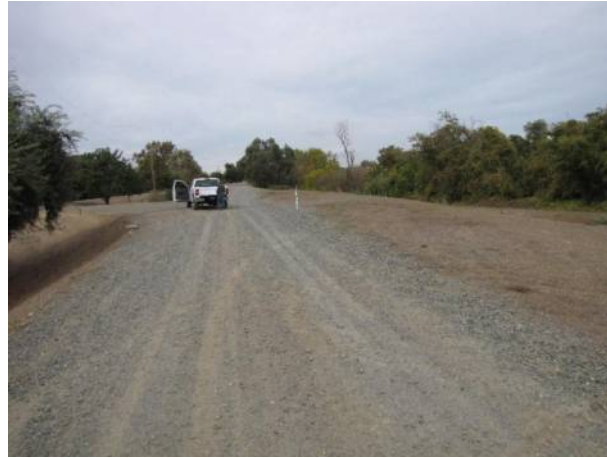
Levee Mile Report Line	100
Start Levee Mile	4.08
End Levee Mile	4.08
Location	Water Side
Category	Supplemental
Item	DWR UCIP Field Study
Overview of levee crown looking upstream at crossing.	
UCIP_5616.jpg

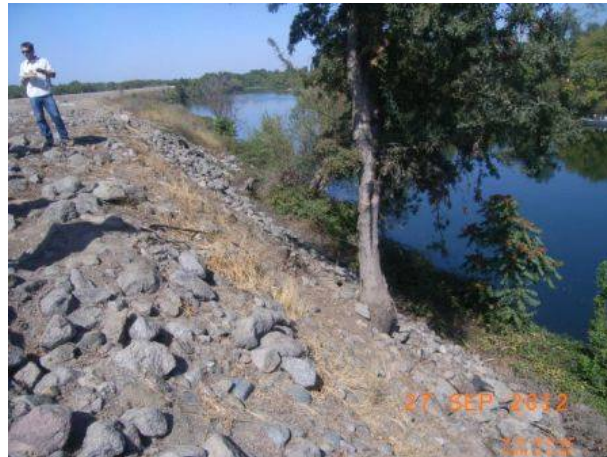
Levee Mile Report Line	103
Start Levee Mile	4.37
End Levee Mile	4.37
Location	Water Side
Category	Supplemental
Item	USACE Erosion Survey
USACE 2012 Photo #1	
USACE2013_FHR_50-9_R_1.jpg

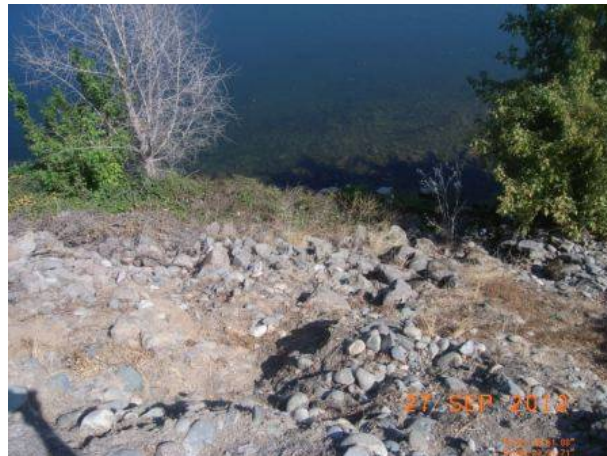
Levee Mile Report Line	103
Start Levee Mile	4.37
End Levee Mile	4.37
Location	Water Side
Category	Supplemental
Item	USACE Erosion Survey
USACE 2012 Photo #2	
USACE2013_FHR_50-9_R_2.jpg
